## Non-destructive testing on aramid fibres for the long-term assessment of interventions on heritage structures

2015 J. Phys.: Conf. Ser. 628 012102

**R Ceravolo<sup>1</sup>, A De Marchi<sup>2</sup>, E Pinotti<sup>1</sup>, C Surace<sup>1</sup>, L Zanotti Fragonara<sup>1</sup>**

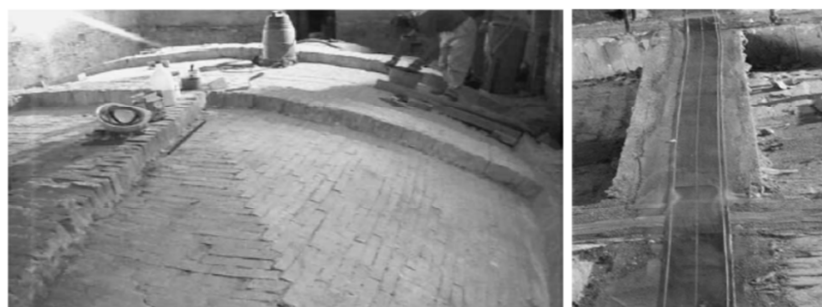
**Figure 1.** (a) The masonry vault and reinforcement arches dated 1600 during surface preparation for CFRP application. (b) Smart CFRP sheet placed on vault [3].

Interesting applications of FRP materials are typically found in the cultural heritage field, where invasiveness of interventions is a major issue. Carbon fibre reinforced polymers (FRPs) are commonly employed for the strengthening and seismic retrofitting of vaults and other masonry elements of heritage buildings (Figure 1). In any case, experimental studies are still required to better understand the durability and compatibility of interventions in polymeric materials and, in general, in other non-traditional materials. For instance, uncertainties about the long term behaviour of aramid fibres made often designers reluctant to their use in the structural engineering fields.

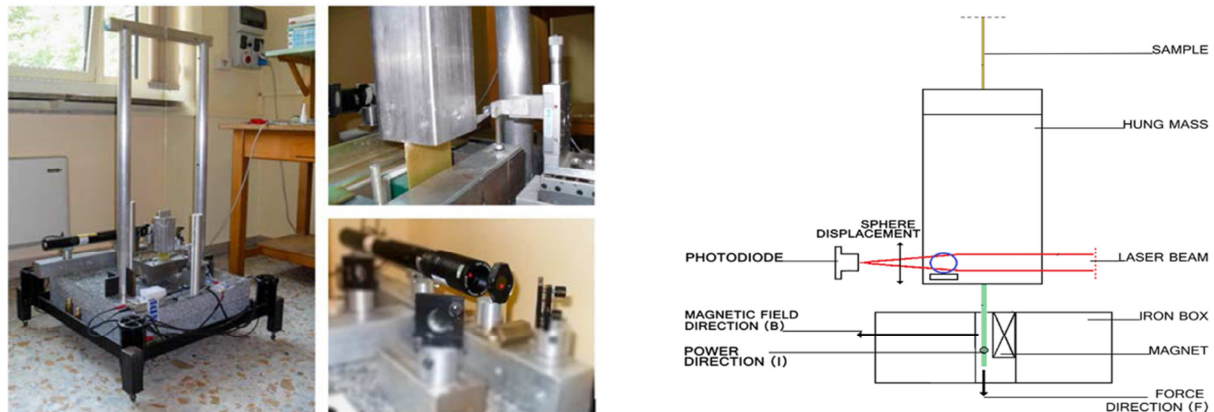
**Figure 2.** (a) The testing setup. (b) Micrometer slides, magnet for forced oscillation testing and hung mass. (c) He-Ne laser beam generator, attenuator and mirrors. (d) Schematic representation.

The testing machine frame (Figure 2.a) is composed of a rectangular crossbeam ( $L=45$  cm, cross section:  $4 \times 4$  cm) made of aluminium, transversely bounded at two cylindrical aluminium holed columns ( $h=95.4$  cm; diameter: 5 cm, thickness: 0.5 cm) on a massive square basement ( $60 \times 60$  cm) made of marble with a thickness of 14.5 cm. An isolation steel table supports the marble mass, this allowing to neutralize most of environment vibrations. The materials used for the testing system were selected in order to minimise the effect of the temperature excursion in the laboratory.

The specimen, consisting of parallel fibres, were mounted vertically, with the top fixed at the horizontal crossbeam and at an aluminium block at the lower part; a special device was inserted at the bottom in order to measure the specimen displacement during the test (Figure 2.b).

A helium-neon generator was used for the experiment (Figure 2.c) in order to produce the laser beam. The device is able to emit a coherent, monochromatic and concentrated light beam in a highly collimated beam straight, through the process of stimulated emission. The laser generator is mounted on a suitable support, so that the laser beam was emitted in the horizontal direction with respect to the anti-vibration table.

An attenuator is an electronic device that reduces the power of a signal without appreciably distorting its waveform. The attenuator was used to prevent saturation of the photodiode, attenuating the beam light (Figure 2.c).

Metal mirrors were used to adjust the direction of the laser beam. They were mounted on supports in order to be adjusted for different inclinations. The combined movement of rotation about the horizontal and vertical axes of the two mirrors allows to determine completely the direction of the light beam (Figure 2.c).

A photodiode, which converts an optical signal to an electric signal, was mounted on three precision micrometre slides. Two of these were assembled together in reference to the X-direction (parallel axis to the plane formed by the optical bench and orthogonal to the laser beam) and Z-direction (orthogonal axis to the plane formed by the optical bench and orthogonal to the laser beam direction). The third slide is positioned in a parallel direction to the bench and the laser beam (Figure 2.b).

In Figure 2.b it is also possible to notice the hung mass of 1.375 kg which was used to form a 1-DoF system with the specimen acting as spring. A copper wire coil was placed inside a magnet and aligned so that an electromagnetic force in the vertical direction could be produced and applied to the hung mass and, consequently, to the fibres (Figure 2.b).

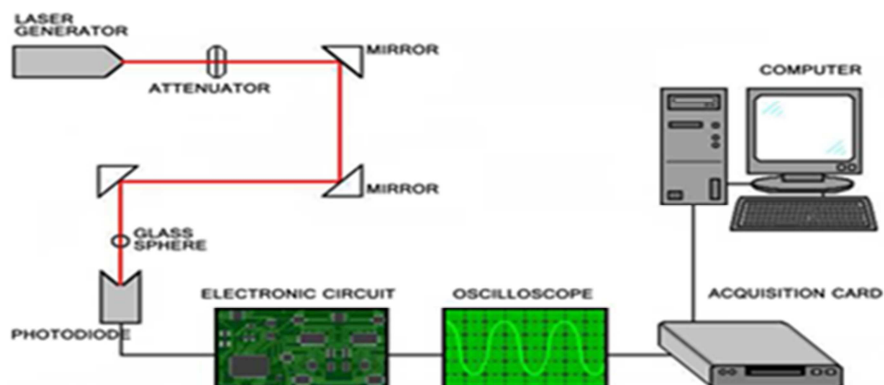
**Figure 3.** Principle of operation - schematic representation.

The principle of operation of the instrumental apparatus used in the tests (Figure 3) can be summarized in the following stages. The light source produced by the laser generator was forced to follow a predetermined path by means of a prism and two lenses. These lenses, if properly set, deflected the laser beam causing it to converge towards the instrument test, where the sample was allocated. In order to allow the photodiode to read the optical signal and, consequently, the possible displacement of the fiber, a glass sphere (connected to the hung mass) with a diameter of 8 mm was used, which, working as a convex lens, focuses the beam to a very precise point of the marker located inside the photodiode (Figure 2.b). The marker was divided into four sectors, generally square. The sensor read the movement of the glass sphere and indirectly the elongation of the fiber, in relation to the quadrant where the laser beam was focused. Therefore, it was important to make a correct positioning of the

photodiode using the micrometer slides. Indeed, for the system in a quiescent state, the read signal was set equal to zero. An electronic circuit was used to link the photodiode to an oscilloscope. An acquisition card and a Lab View application were used to record the collected data on csv files.

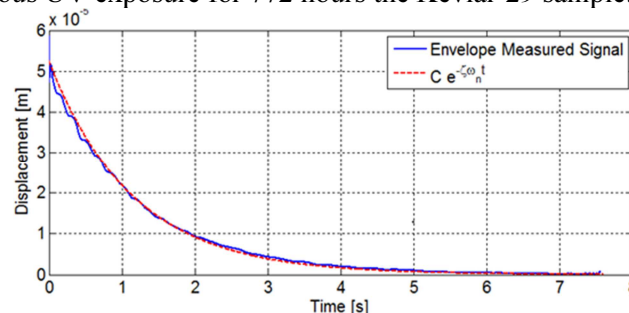
**Figure 4.** Kevlar-29 pristine sample: fitting of the envelope of the acquired signal.

In order to characterise the dynamic behaviour of the fibres, free-decay tests were performed. The tests allowed for the identification of natural frequencies and damping ratios of both specimens. The system identification was achieved with time domain fitting techniques applied to the Hilbert transform envelops of the acquired signals (Figures 4 and Figure 5). Results were also validated by using standard ERA techniques [8].

The application of curve fitting techniques over free-decay signals sampled at 2500 Hz gave for the Kevlar-29 pristine samples, a resonance frequency of  $(20.30 \pm 0.03)$  Hz and an experimental damping ratio of  $(0.7 \pm 0.1) \%$ ; whilst for the Kevlar-29 damaged samples, a value for natural frequency of  $(19.80 \pm 0.02)$  Hz and experimental damping ratio equal to  $(0.6 \pm 0.1) \%$  were evaluated. The spread of the results was computed using 7 free-decay measurements for both samples. The high sensitivity of the measurement device allows to quantify low damping ratio and frequencies with a high level of accuracy. These damping ratios can be directly linked to the intrinsic material dissipation factor, because all other dissipation phenomena can be actually neglected. The mean value of the natural frequency was used to estimate the elastic dynamic modulus of the fibres.

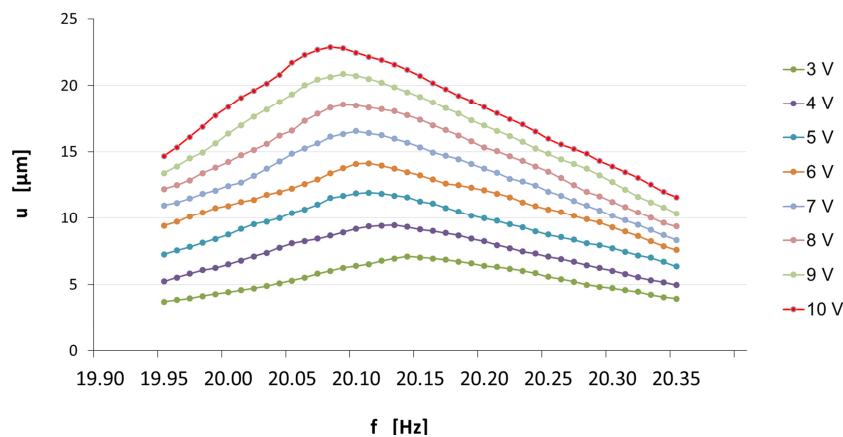
**Figure 6.** Response spectra for increasing values of the input force – pristine sample.

In order to highlight possible non-linearities, campaign with harmonic forced excitation tests was set up. The frequency range investigated was of  $\pm 0.200$  Hz with respect to the resonance frequency of the system, with a step excitation frequency chosen equal to 0.010 Hz while keeping the force constant. Then the test was repeated for different level of force, the amplitude being varied by adjusting the voltage applied through a function generator in steps from 3 V to 10 V, corresponding to forces induced by the electromagnetic field that were in the approximate range of 10-30 mN (see Figure 2.b and 2.d). The value of the amplitude of the static force at resonance was estimated at approximately 0.9 N at the lowest level applied, and 3.1 N at the highest.

Once the input voltage interval has been defined, changing the frequency of the driving force (via the function generator) it is possible to record the values of the output voltage, from which the displacement can be determined by using a conversion factor established during the photodiode calibration. The results are reported in Figure 6 and Figure 7.

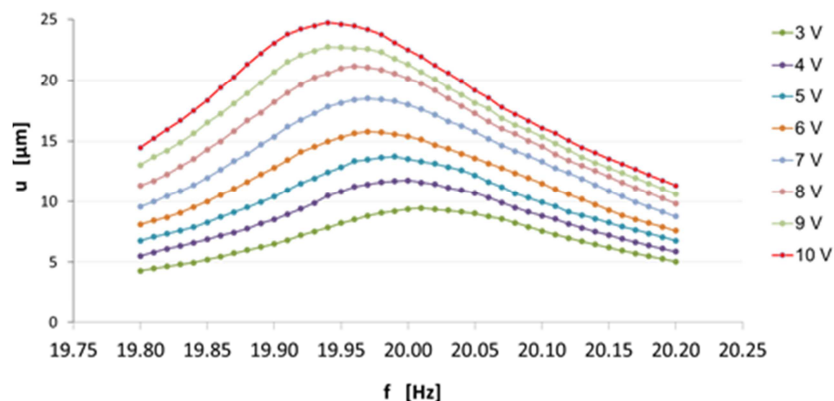
**Figure 7.** Response spectra for increasing values of the input force – damaged sample
